**EMERGENCY SPILLWAY PERFORMANCE,
UPPER RED ROCK CREEK WATERSHED,
OKLAHOMA**

ARS-S-108

May 1976

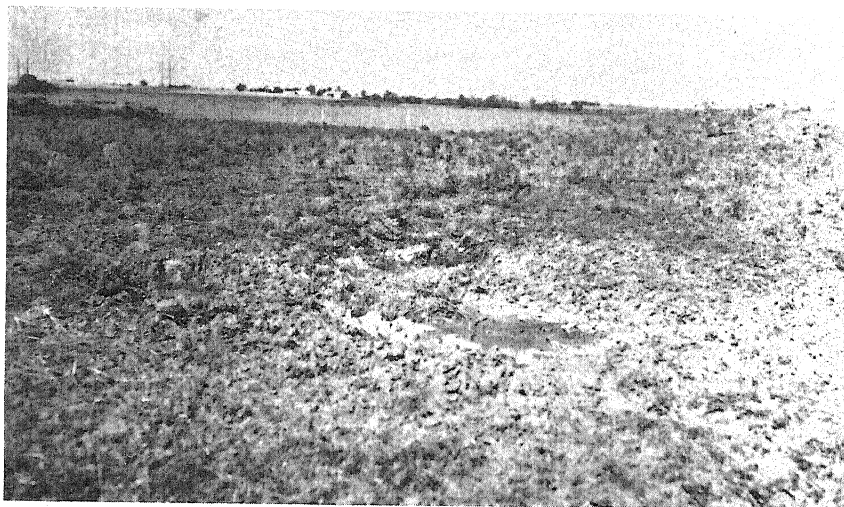
Figure 5 is a closeup view of the head of one of the deeper rills. The scour here is about 2 feet deep and extends to the shale bedrock. This part of the spillway was subjected to the 6.7 feet per second flow velocity. Immediately downstream of the spillway crest is a small area scoured to a depth of 5 inches (fig. 6).

FIGURE 6.—Scoured area in site 24 spillway just downstream from spillway crest. The cover on the adjoining area is thin, poor, and short.

The site 24 spillway started to erode during a flow event which had a peak mean velocity of 6.7 feet per second. The spillway appeared to have been heavily grazed, and this may have been responsible for its condition. Cattle trails and “stomp” areas were present in the spillway at the time of inspection. Therefore, it is reasonable to assume that the eroded areas also had suffered from similar cattle activity.

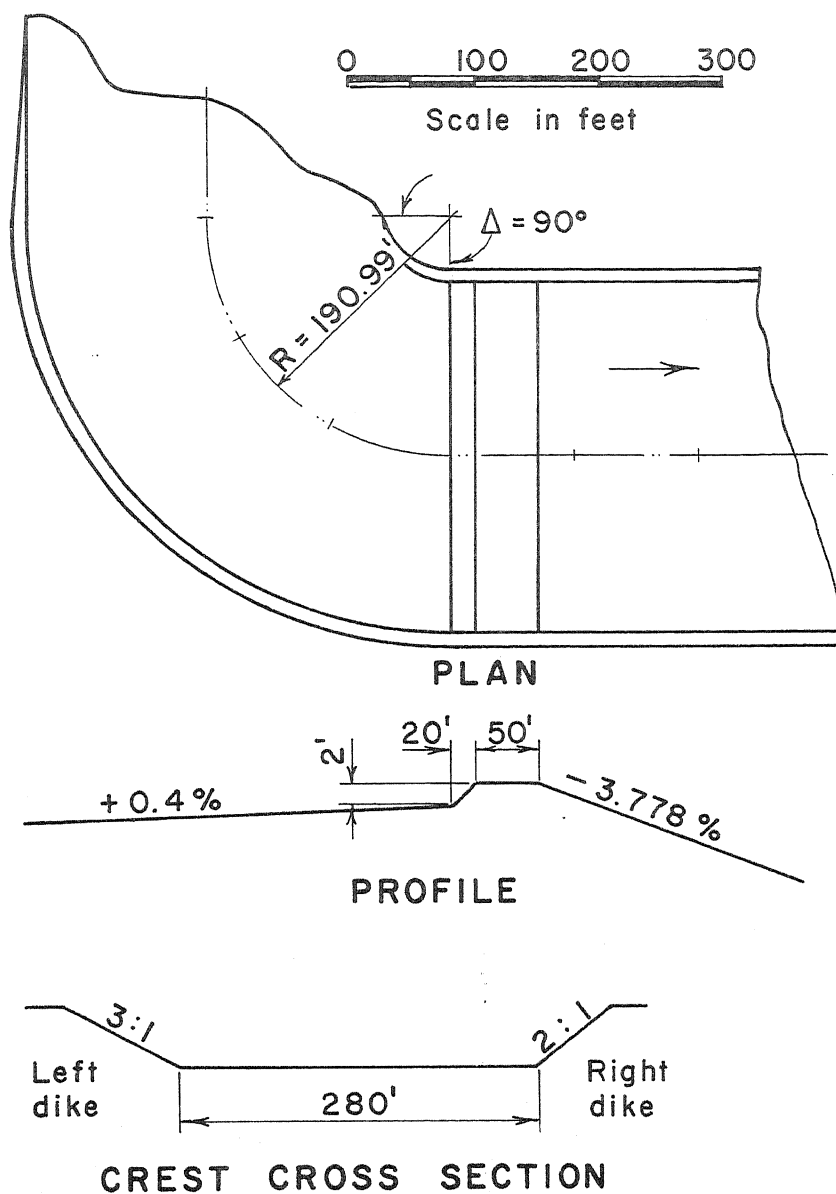
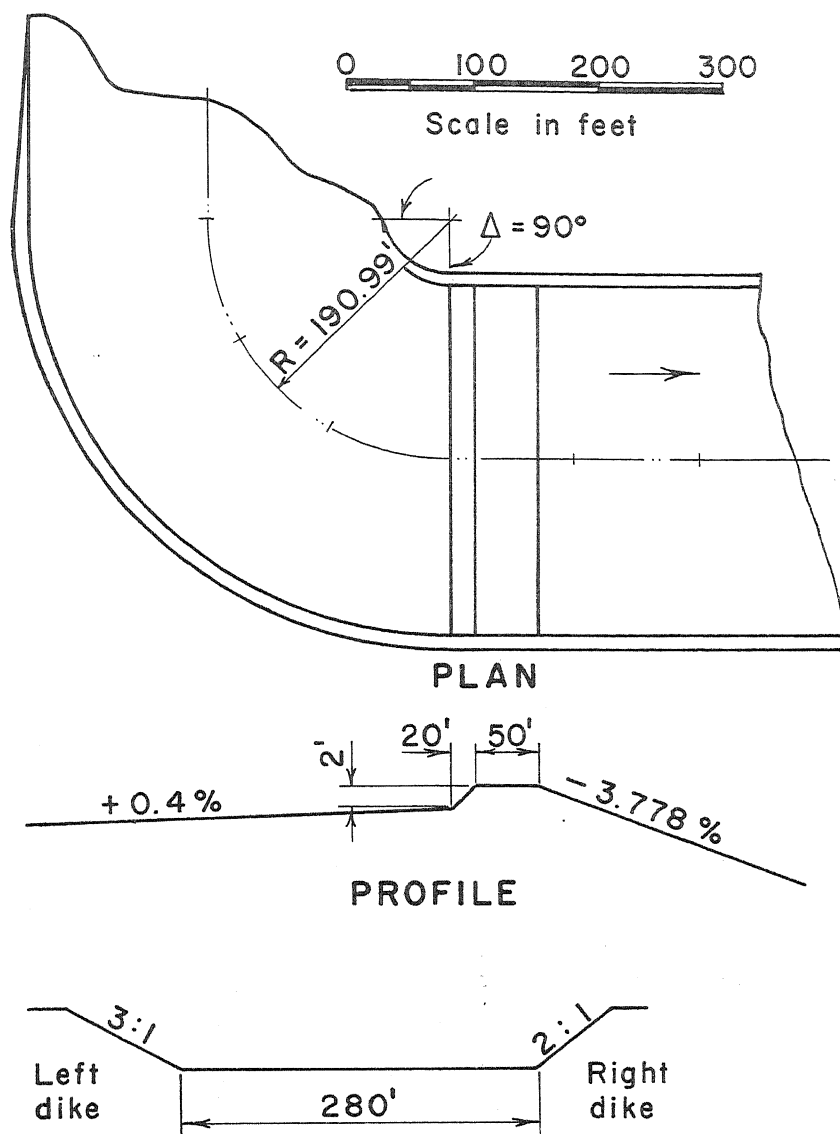
FIGURE 7.—Emergency spillway dimensions, site 25.

The emergency spillway is at the right end of the dam. Its dimensions are shown in figure 7. A minimum of 6 inches of topsoil had been placed on the spillway surface after excavation and shaping. At the time of the flood the spillway had a very uniform, good cover of bermudagrass, with a scattering of a short, fine-leaved grass and broomweed. The spillway had been grazed, and the grass was relatively short. Its flow retardance was estimated to be class E.

Runoff from the storm was sufficient to cause flow in the emergency spillway. The water surface elevation reached a maximum of 1.3 feet above the crest of the emergency spillway. The peak outflow rate for this head was estimated to be 767 cubic feet per second (by the procedure described in the presentation of the site 24 data). A water surface profile computation for a discharge of 767 cubic feet per second showed that the slope of the spillway was
